**LAKE CHILLISQUAQUE**

NDS ID NO. PA-815

PHASE I INSPECTION REPORT  
NATIONAL DAM INSPECTION PROGRAM

NAME OF DAM: Lake Chillisquaque Dam  
STATE LOCATED: Pennsylvania  
COUNTY LOCATED: Montour  
STREAM: Middle Branch of Chillisquaque Creek  
DATE OF INSPECTION: May 23, 1979

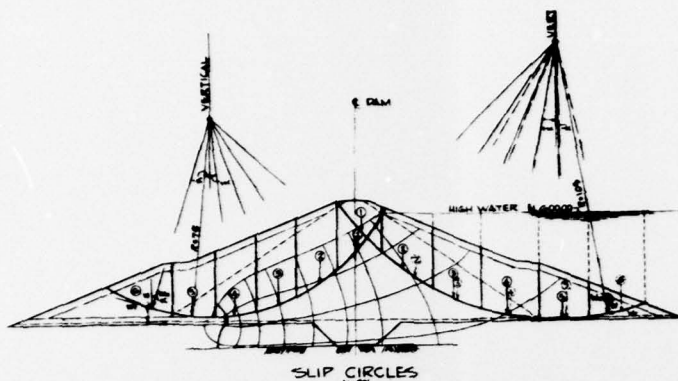
COMPLETE RAPID DRAWDOWN U.S. SLOPE														E=0.9	F <sub>0</sub> =1.17
SLICE NO.	GEOMETRIC PROPERTIES					SOIL PROPERTIES					COMPLETE DRAWDOWN				
	WIDTH FT.	HEIGHT FT.	AREA SQ. FT.	$\bar{x}$ FT.	$\bar{y}$ FT.	$\bar{c}$ FT.	$\bar{\tan \phi}$	$\bar{c}_{\text{avg}}$ FT.	$\bar{\tan \phi}_{\text{avg}}$	$\bar{c}_{\text{avg}}$ FT.	$\bar{\tan \phi}_{\text{avg}}$	$\bar{c}_{\text{avg}}$ FT.	$\bar{\tan \phi}_{\text{avg}}$		
1	17.0	10.4	177	47.0	7.31	6.02	24.0	15	26.0	50	12.0	11.8	20.1	18.7	
2	20.0	21.0	420	55.4	8.81	4.14	25.0	15	26.0	50	12.0	12.4	20.1	18.7	
3	20.0	24.2	486	59.4	9.99	4.17	25.0	15	26.0	50	12.0	12.4	20.1	18.7	
4	20.0	28.6	576	64.0	10.2	4.17	25.0	15	26.0	50	12.0	12.4	20.1	18.7	
5	20.0	18.0	375	51.0	10.7	4.17	25.0	15	26.0	50	12.0	12.4	20.1	18.7	
6	20.0	7.5	150	40.5	10.2	4.17	25.0	15	26.0	50	12.0	12.4	20.1	18.7

$F_0 = \frac{E(WH) \tan \phi + E(C.H.)}{E.W.} = \frac{0.9(17.0)(10.4) \tan 24.0^\circ + 0.9(420)(8.81) \tan 25.0^\circ}{0.9(17.0)(10.4) + 0.9(420)(8.81)} = 1.17$

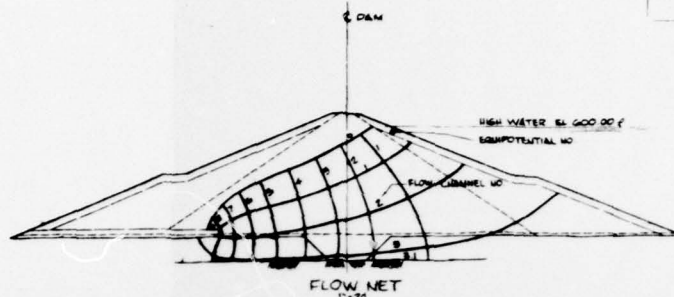
STEADY SEEPAGE D/S SLOPE														
E=17' F=172														
SLICE NO	WIDTH FT	HEIGHT FT	AREA SQ FT	W	H	W/H	W/H	W/H	W/H	W/H	W/H	W/H	W/H	W/H
1	18.5	16.1	275	490	755	656	28.0	19	28.0	50	112	110	57.5	21.6
2	15.0	28.8	475	56.0	559	889	28.0	15	26.0	50	117	55.5	66.0	34.0
3	15.0	31.5	508	50.0	245	788	27.0	15	26.0	50	118	60.1	56.0	32.0
4	15.0	28.5	472	7.0	122	1992	28.0	15	26.0	50	114	58.7	53.5	6.6
5	17.0	24.5	495	5.0	207	794	17.0	15	26.0	50	117	48.7	48.1	4.2
6	27.5	11.0	302	19.0	285	786	25	26.0	50	110	76.3	58.4	11.5	34.4
$F_s = \frac{(\sum W) - U}{\sum W} = \frac{655.4 - 109.2}{655.4} = 1.72$ $E = 17'$ $F = 172$

PERMEABILITY SILTY CLAY - WEATHERED SHALE - 10' MIN  
 FLOW THROUGH DAM MAXIMUM SECTION  
 $Q = K \cdot H \cdot A$   
 $Q = 1.72 \times 10^{-4} \text{ (CGP/FOOT)} \times 5 \text{ (GP/FOOT)}$
